**East Bannister Road Commercial Buildings
8202 - 8500 East Bannister Road
Kansas City, Jackson County, Missouri 64134**

PROPERTY CONDITION ASSESSMENT

FINAL REPORT

PROJECT 1914095

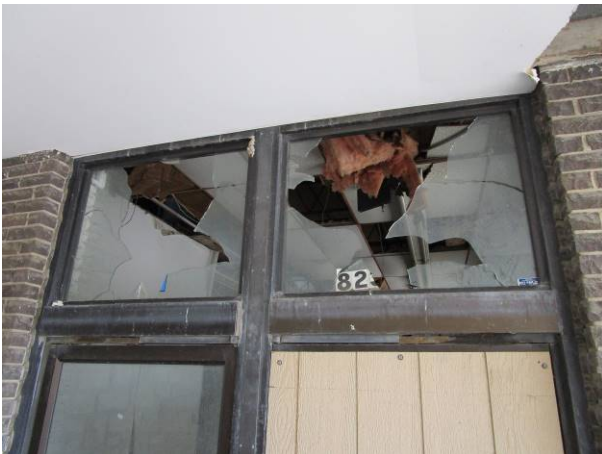
1. Example of damaged windows

ITEM	DESCRIPTION	COST
1.	Repair interior finishes of twenty suites in Parcel 1 Building and the total interior finishes of the Parcel 2 Building to include: removal of damaged ceiling tiles, interior walls, mold abatement, removal of flooring finishes; repair / replacement of plumbing piping, installing new walls, drop ceilings, flooring, repair windows and doors. Estimated 100,750 square feet (based on current rent roll) estimated cost repair of \$ 5 per square foot.	\$ 503,750
2	Repair of the damage building roof. Majority of damage isolated to western 3/4 of the building; approximately 56,000 square feet.	\$ 224,000
	TOTAL	\$727,750

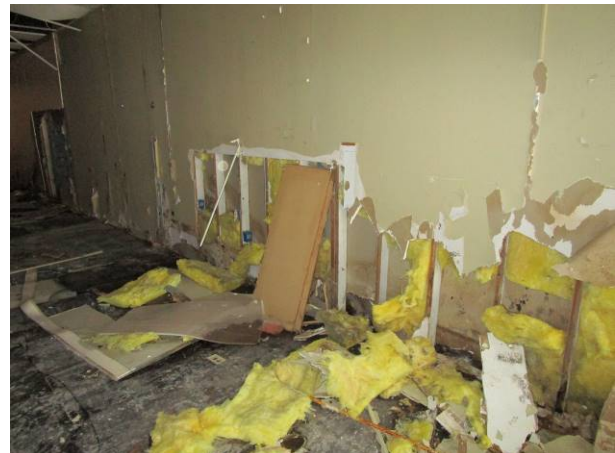
2. Example of damaged interior finishes

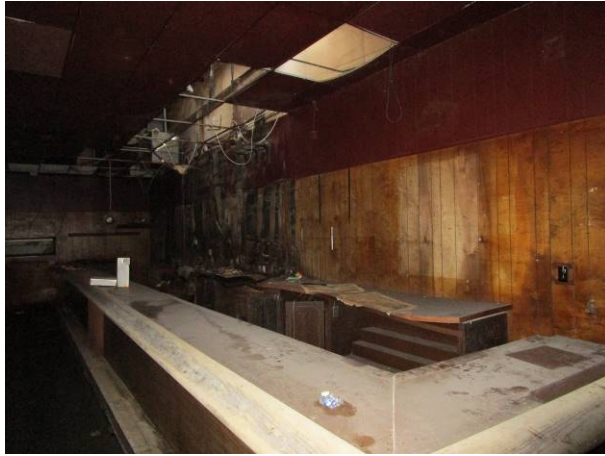
3. Example of damaged interior finishes

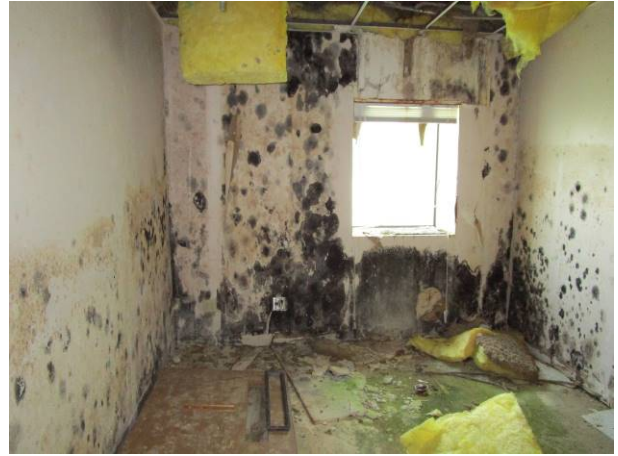
4. Example of mold growth.

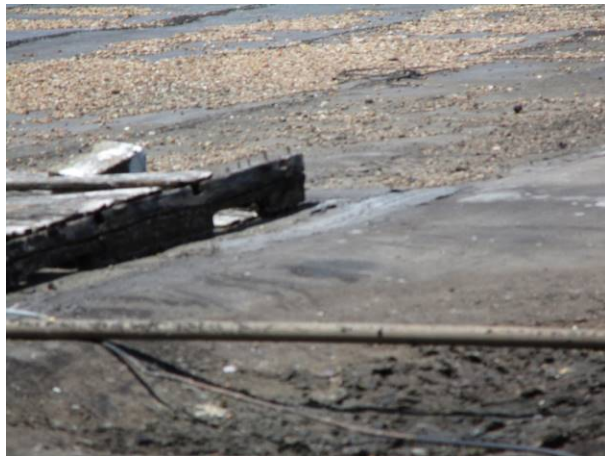
5. Example of damaged roof

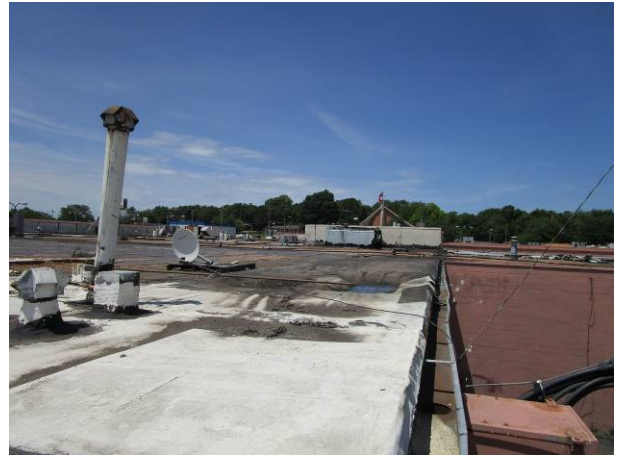
6. Example of damaged roof

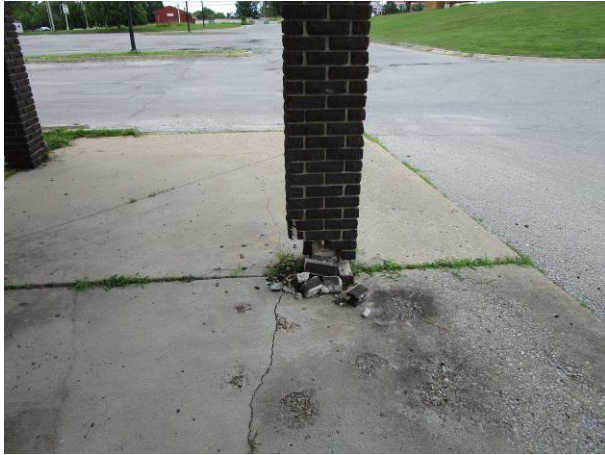
1. Example of damaged pillar

ITEM	DESCRIPTION	COST
1.	Repair support pillar located proximate to Unit 3220.	\$ 1,000
2	Replace damaged or missing HVAC equipment components from roof top units. Estimated 20 affected units. Identified as a PR-90 repair due to condition of roof.	\$200,000
	TOTAL	\$ 201,000

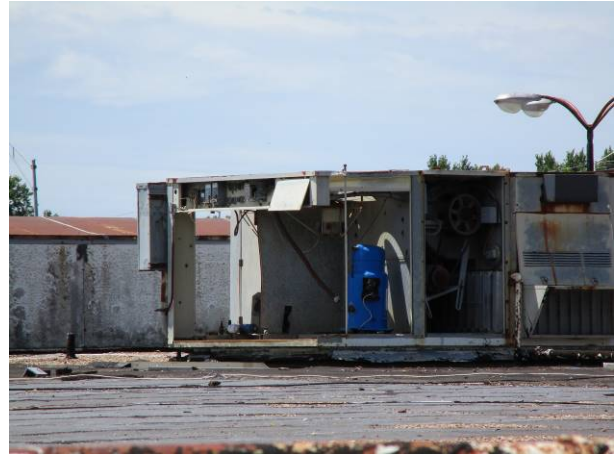
2. Example of damaged HVAC Unit

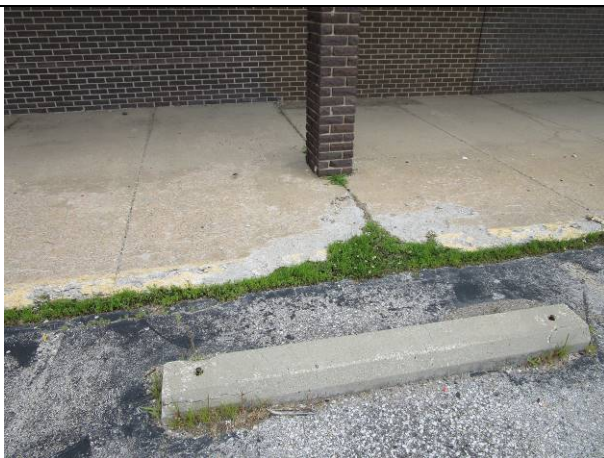
1. Example of damaged walkway

ITEM	DESCRIPTION	COST
1.	Repair damaged (cracked) concrete walkways proximate to Suites: 8208, 8216-18, 8226, and 8228-32. Estimate repair average \$750 / walkway	\$ 3,000
	TOTAL	\$ 3,000

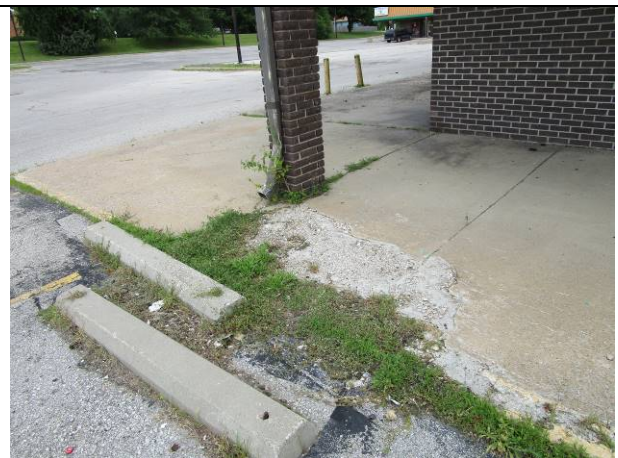
2. Example of damaged walkway

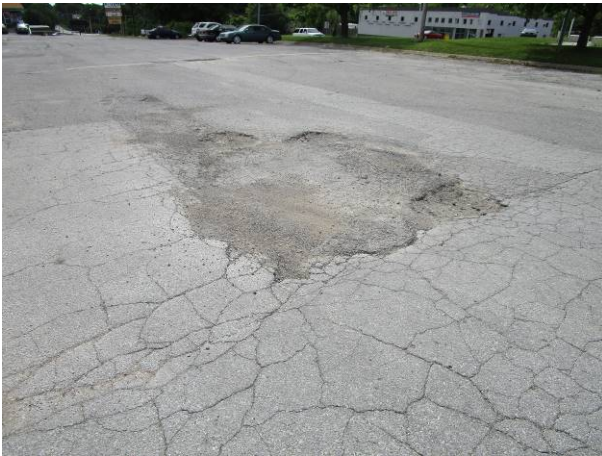
1. Example of damaged parking lot

ITEM	DESCRIPTION	COST
1.	Repair damaged parking surfaces throughout: repair cracks / potholes, remove vegetation. Estimated affected area 50,000 square feet	\$ 50,000
2.	Repair building exterior finish. Repair damaged finish concrete skim coat and remove peeling paint / repaint.:	\$ 10,000
3.	Remove overgrown vegetation proximate to buildings.	\$ 5,000
4.	Install 15 designated ADA parking spaces completed with signage	\$ 3,000
	TOTAL	\$ 68,000

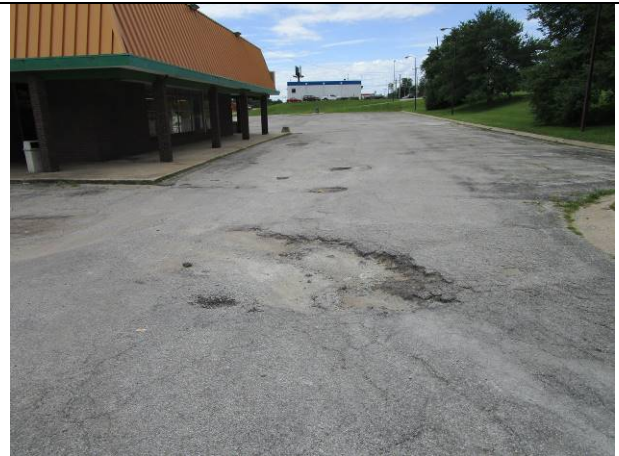
2. Example of damaged parking lot

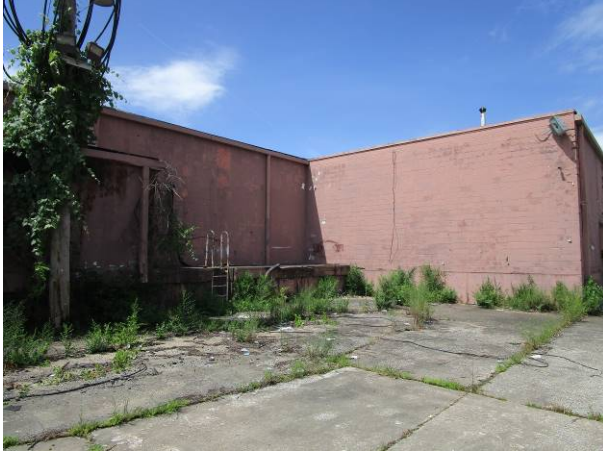
3. Example of damaged parking lot

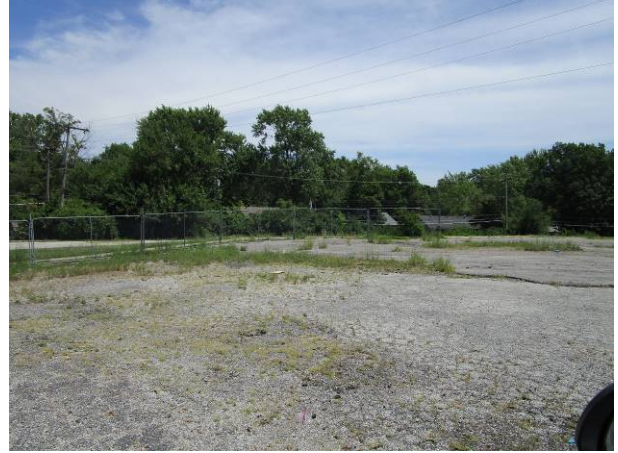
4. Example of damaged parking lot.

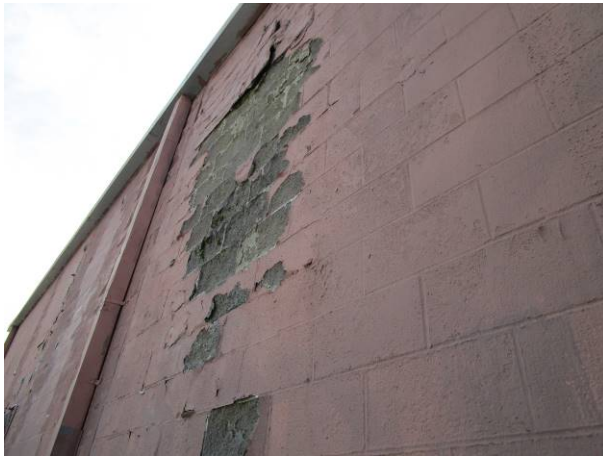
5. Example of damaged exterior finish

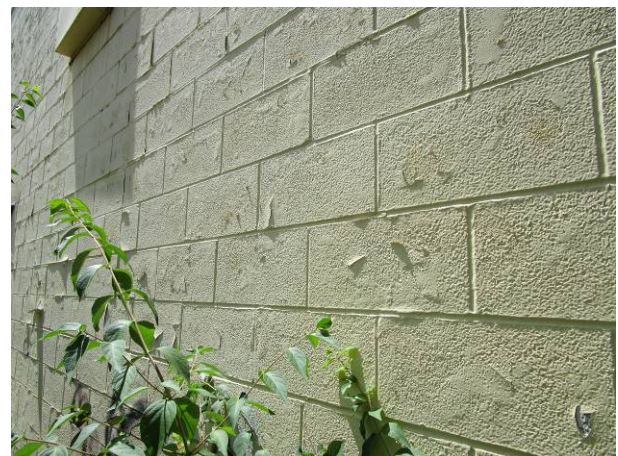
6. Example of peeling paint

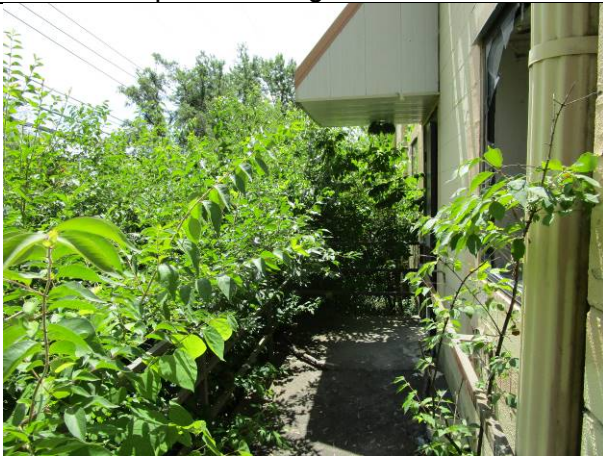
7. Example of vegetation overgrowth

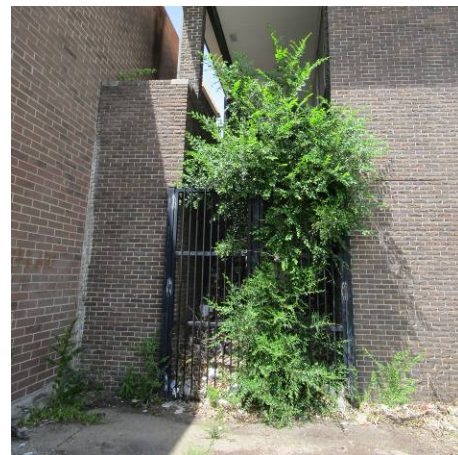
8. Example of vegetation overgrowth

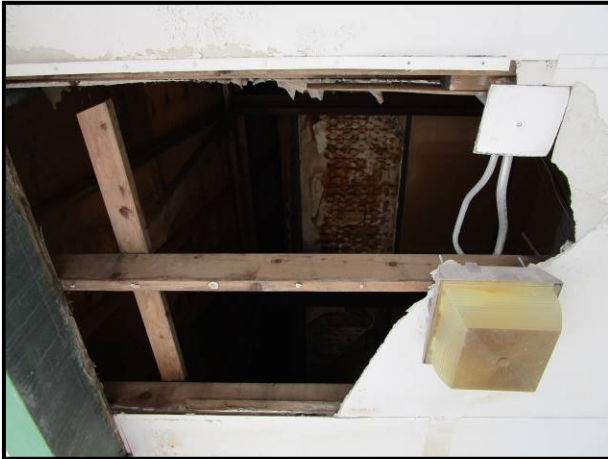
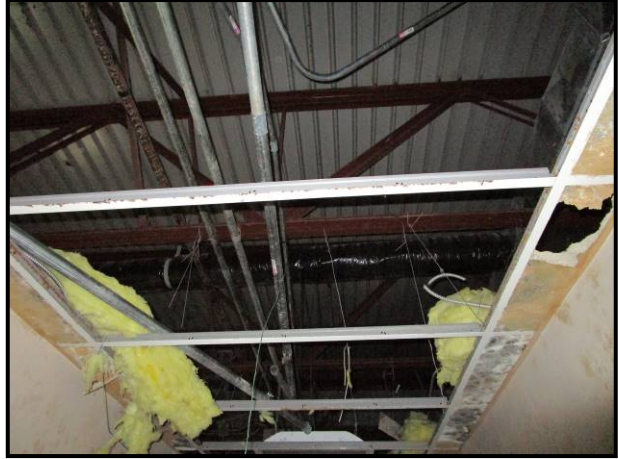
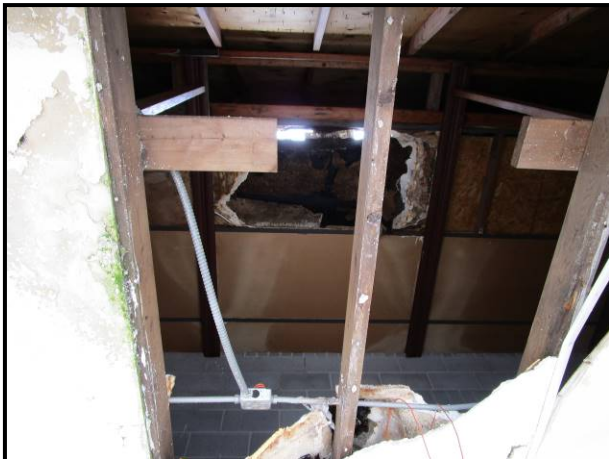
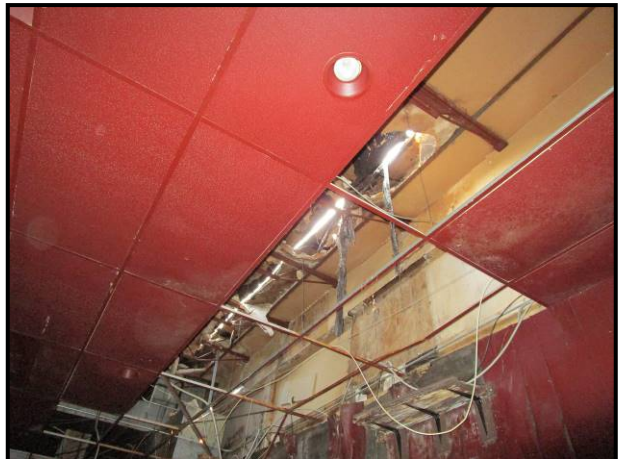
Due to the holes observed in the roof of the Parcel 1 Building, REA was able to see rusted areas on the metal support framing for the roof. REA also observed water stain marks on the wood framing observed through holes in the soffits. REA anticipated repair / replacement of the metal / wood framing in these areas. Associated costs for this work are found in the Immediate Repair Needs Table.

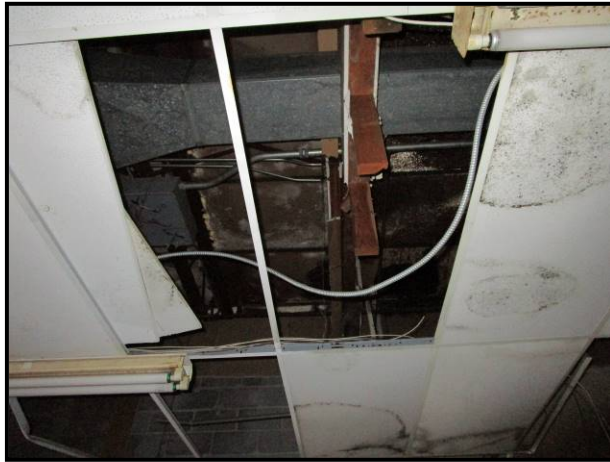
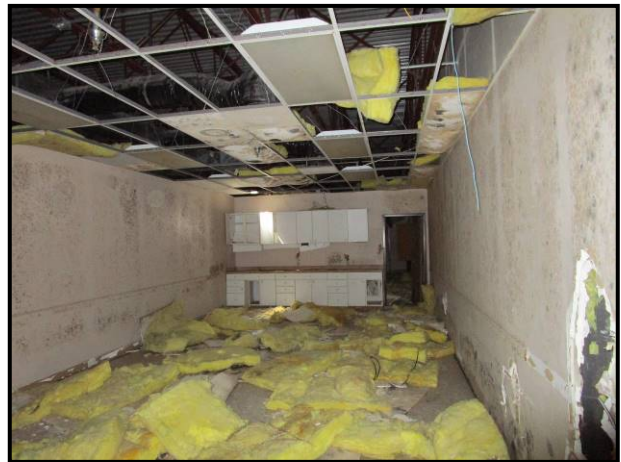
REA noted significant deficiencies regarding insulation. Due to damage in the roof of Parcel Building 1, REA noted to lack of insulation above the drop ceiling in accessible units. REA noted a significant amount of the batt insulation in Parcel 2 Building to be laying on the ground. REA anticipates complete replacement of the batt insulation throughout the Property buildings necessary prior to being rentable and has identified these repairs as Operational Repairs; associated costs for this work are found in the Immediate Repair Needs Table.

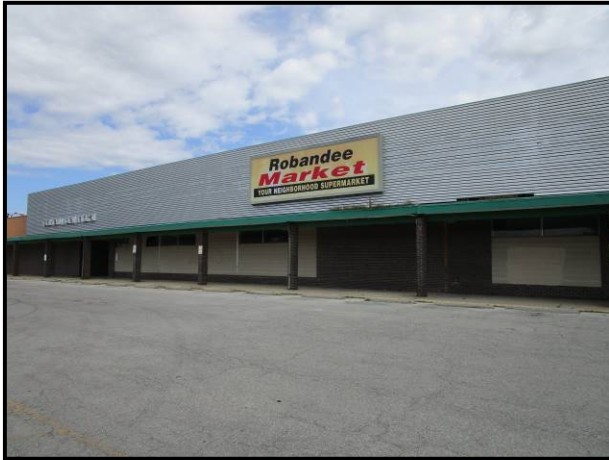
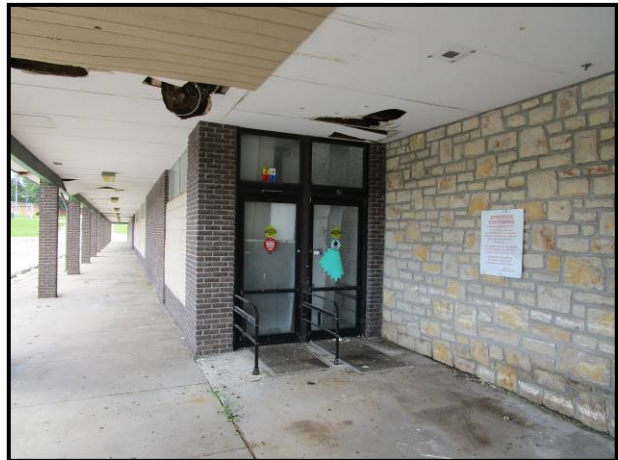
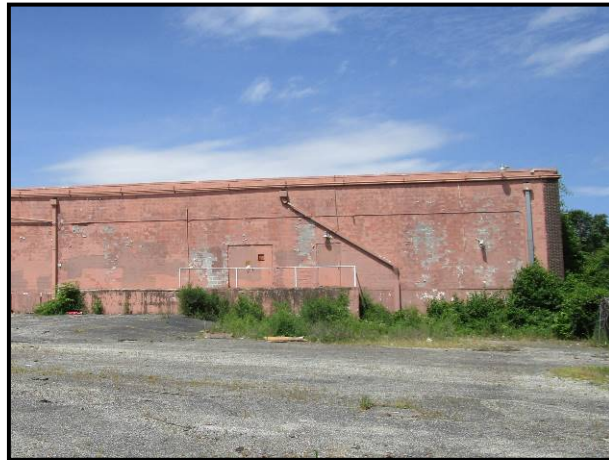
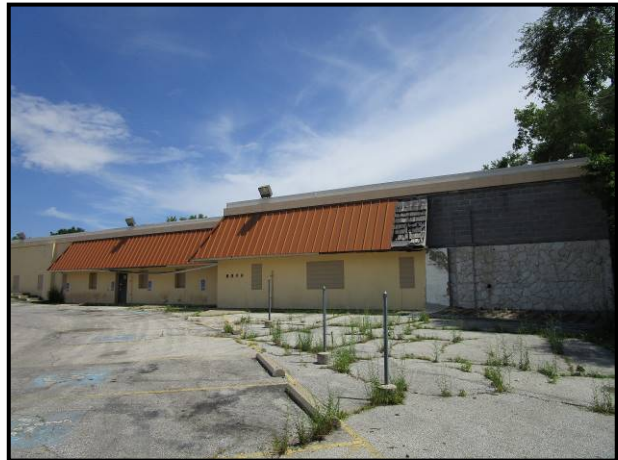
REA noted the brick veneer and stone veneer to be in good condition throughout. REA also noted that on the Parcel 1 Building the finish on the rear of the building; the finish of the CMU, was pitted and delaminating in isolated sections throughout. The painted finish on the Parcel 2 Building was observed to be peeling and worn. REA has identified the repair / repaint of the building exteriors as Operational Repair needs and associated costs for this work are found in the Immediate Repair Needs Table.

REA also anticipates routine maintenance of the building exteriors during the term; associated costs for this work are found in the Replacement Reserve Worksheet.

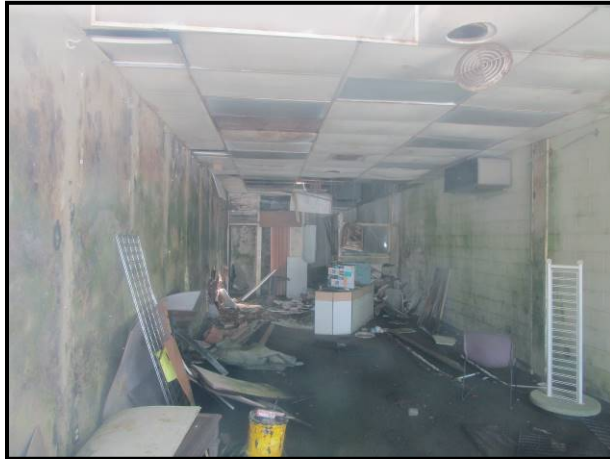
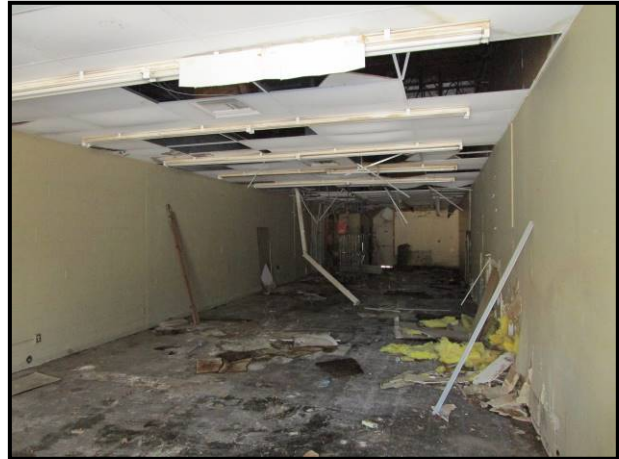
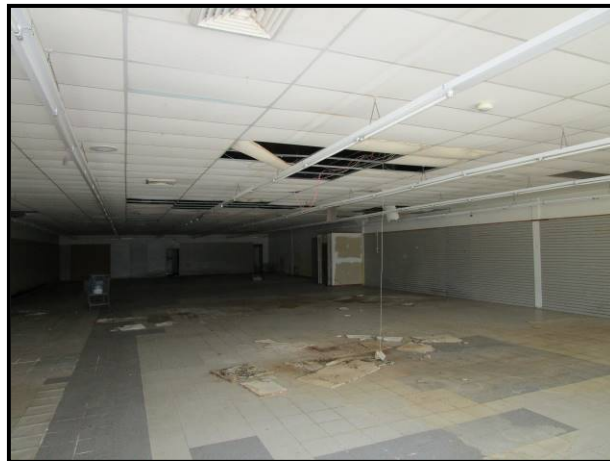
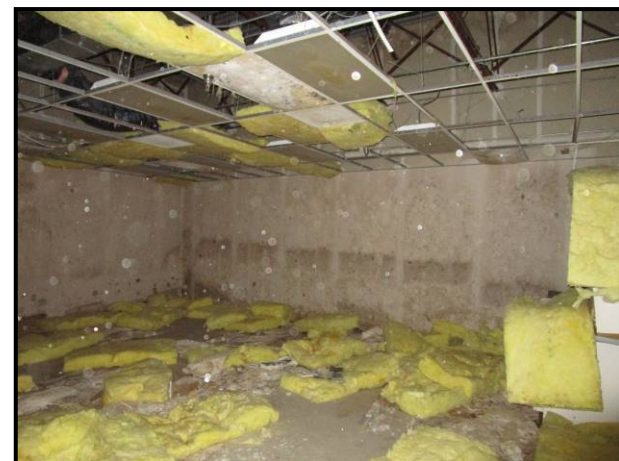
REA also had access to the Parcel 2 Building and noted the following conditions: broken doors (unable to close), broken or missing windows, water damage to ceiling tiles, walls, and floor finishes, holes in walls.

Due to the extensive damage observed within the vacant tenant spaces, REA has identified the repair / replacement of basic interior finishes; drop ceilings, walls and floor finishes as a Critical Repair need as defined:

Associated repair / replacement costs are found in the Immediate Repair Needs Table.

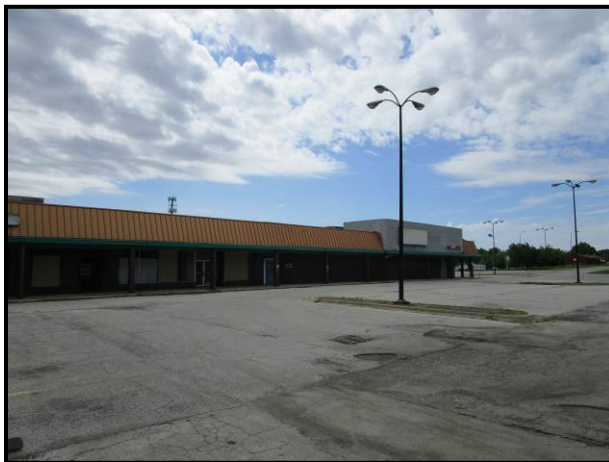
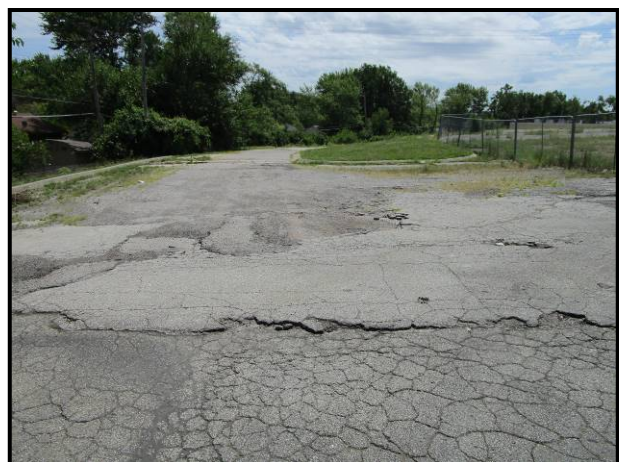
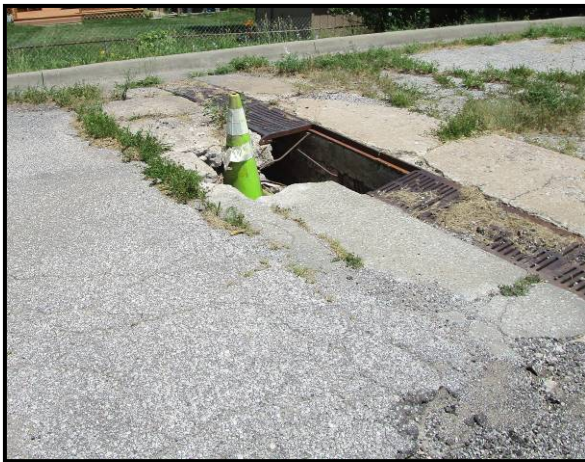
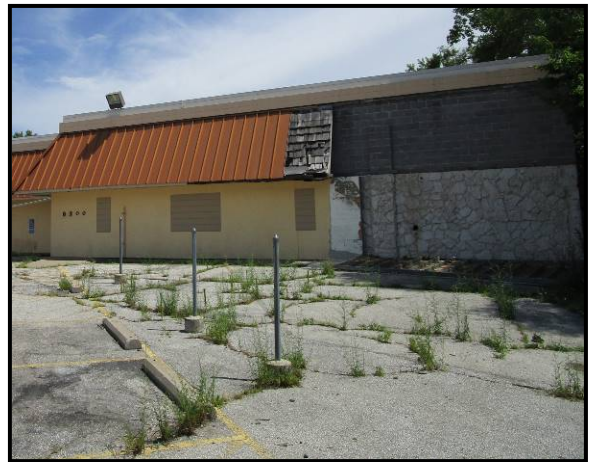
REA estimated approximately 50,000 square feet of parking surface needing repair. REA has identified this as an Operational Repair need with associated repair costs found in the Immediate Needs Repair Table.

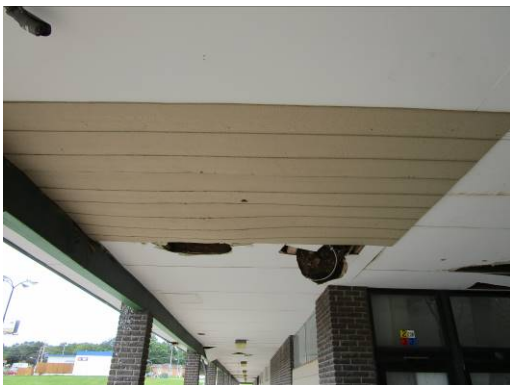
5. Typical soffit damage.

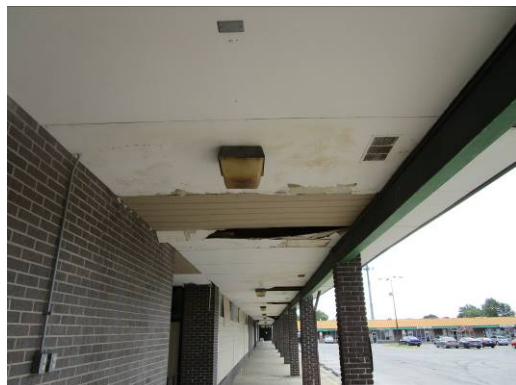
6. Typical soffit damage.

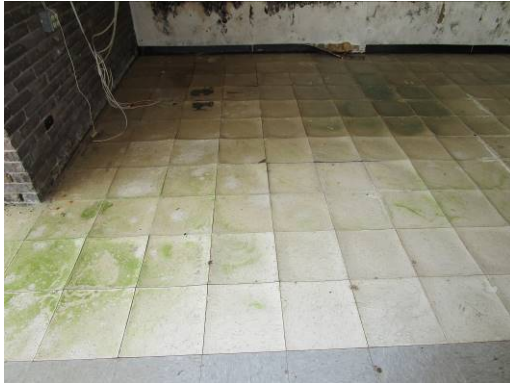
13. Typical damaged flooring in vacant unit
