**East Bannister Road Commercial Buildings
8202 - 8500 East Bannister Road
Kansas City, Jackson County, Missouri 64134**

PROPERTY CONDITION ASSESSMENT

FINAL REPORT

PROJECT 1914095

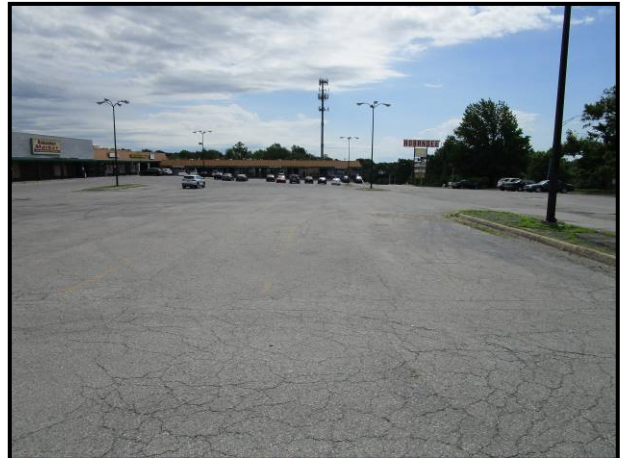
The Property features ± 360 open parking spaces. Property Representative did not know when the parking areas and drives were last sealed and striped. In addition to the immediate repairs identified, REA anticipates routine maintenance of the driveways and parking areas during the term. REA has accounted for the associated costs in the Replacement Reserve Worksheet.

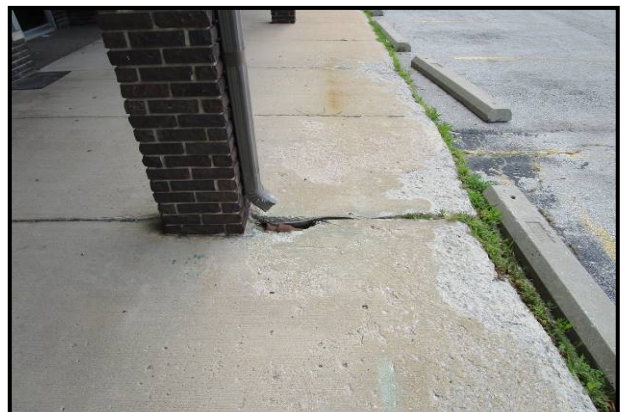
Curbing and sidewalks, which consisted of poured in-place concrete, was observed to be in fair condition. As previously reported in this report, the Property features concrete walkways abutting the Parcel 1 Building that provided access to the individual tenant spaces. REA observed isolated areas of damaged concrete proximate to Suites: 8208, 8216-18, 8226, and 8228-32. REA has identified these areas as Priority Repair needs due to potential trip hazards; associated repair costs are found in the Immediate Needs Repair Table.

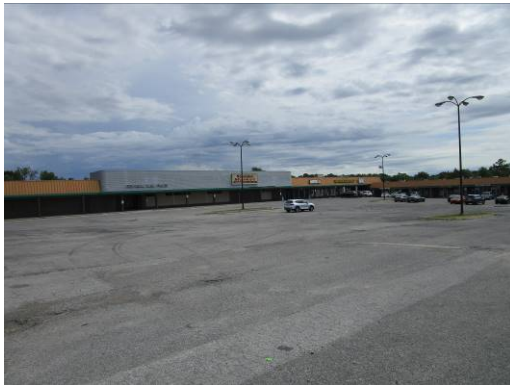
1. Property parking lot and Parcel 1 Building.

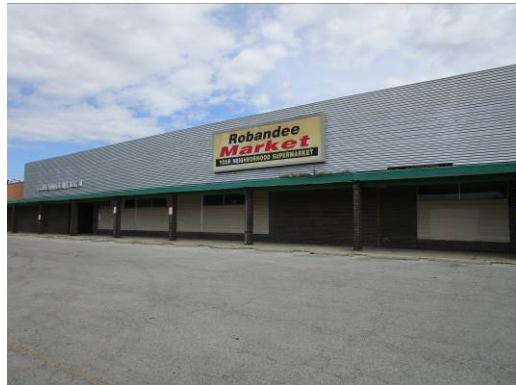
2. Former anchor store; currently vacant suite

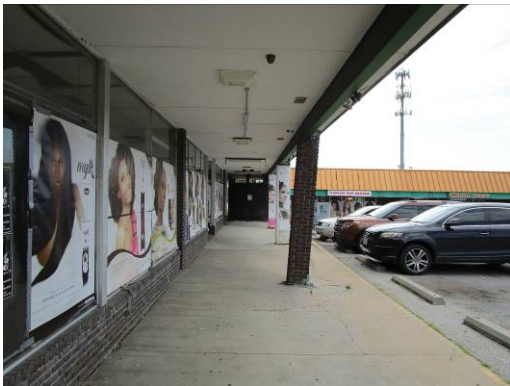
3. Typical concrete walkway / unit entry.

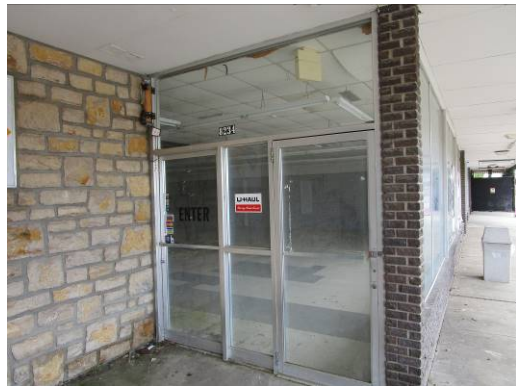
4. Typical entry doors.

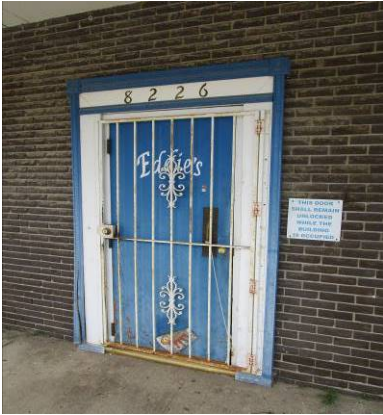
7. Typical non-glass door unit entry.

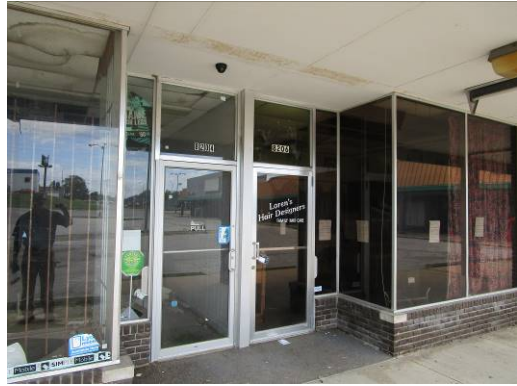
8. Typical glass store fronts.

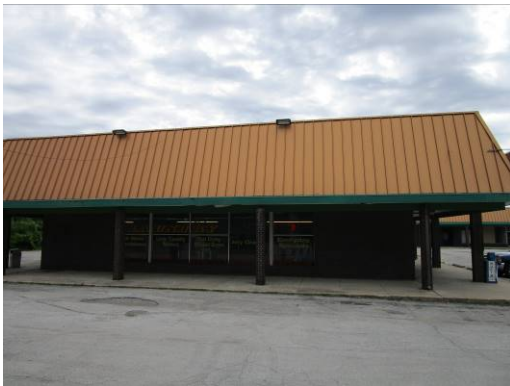
9. Typical soffit roof configuration.

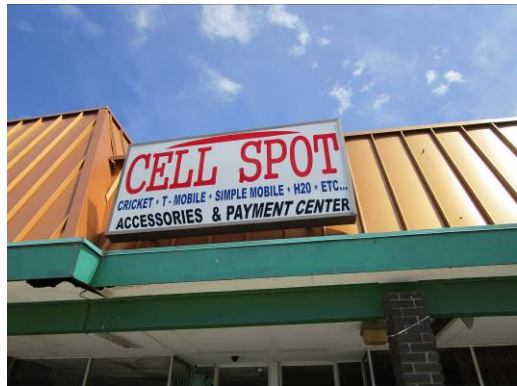
10. Typical store signage.

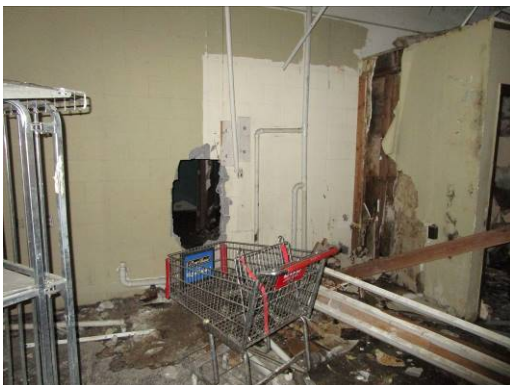
11. Typical vacant unit.

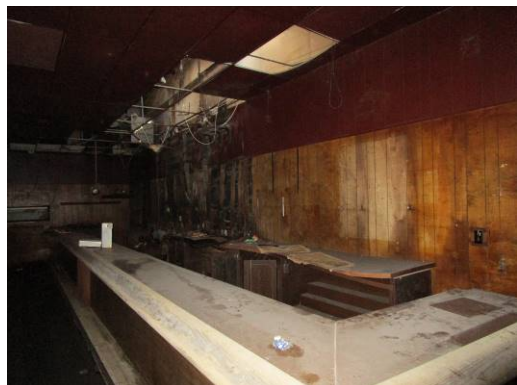
12. Typical vacant unit.

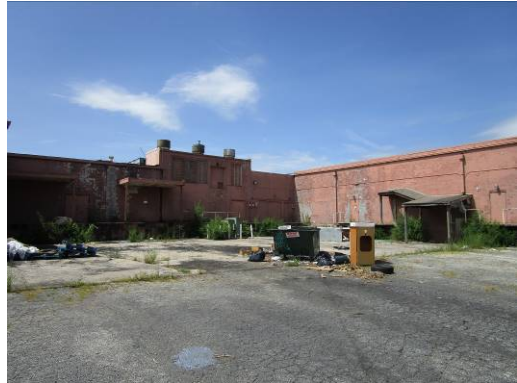
14. Typical condition of rear loading docks area of Parcel 1 Building

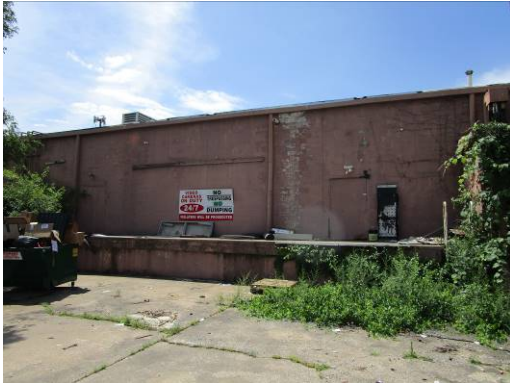
15. Typical rear of Parcel 1 Building.

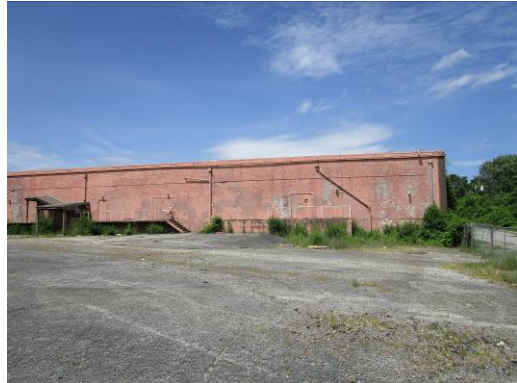
16. View of rear parking lot of Parcel 1 Building.

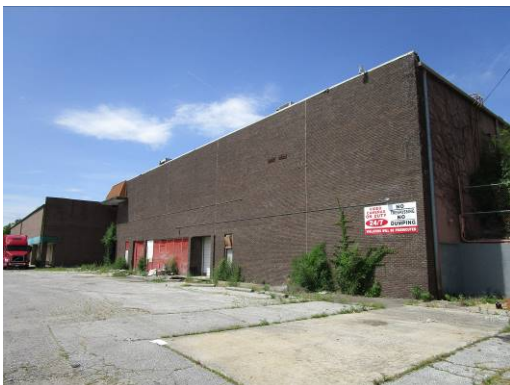
17. East side of Parcel 1 Building showing basement level.

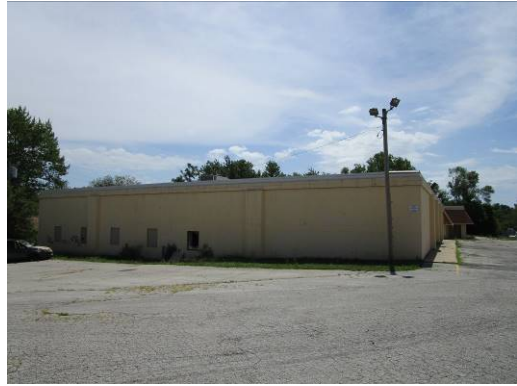
20. Side elevation of Parcel 2 Building.

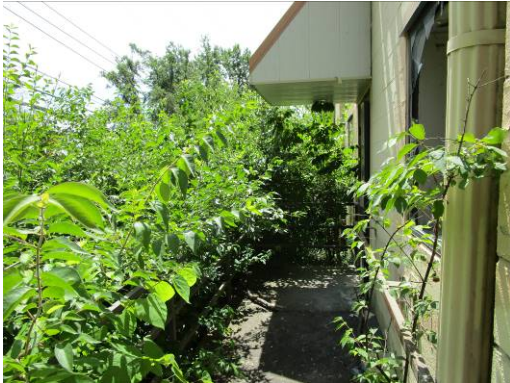
21. Back side of Parcel 2 Building.

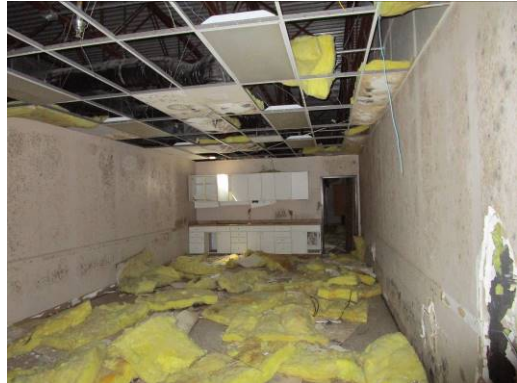
22. Interior view of Parcel 2 Building.

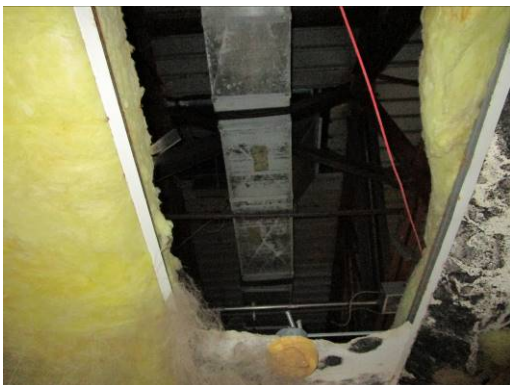
23. View of roof components of Parcel 2 Building.

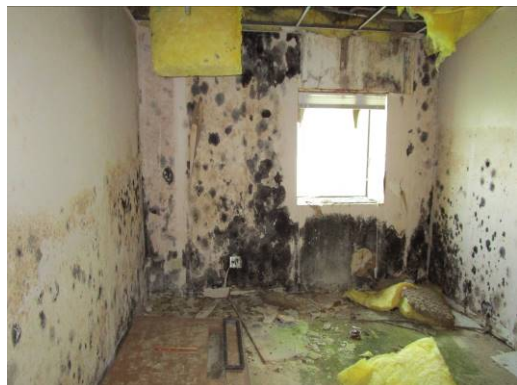
24. Typical office area within Parcel 2 Building.
